Land Subsidence Rate in the Willcox and Kansas Settlement Areas, Cochise County
Based on Sentinel-1 Satellite Interferometric Synthetic Aperture Radar (InSAR) Data
Time Period of Analysis: 0.9 Years 03/11/2021 To 01/17/2022

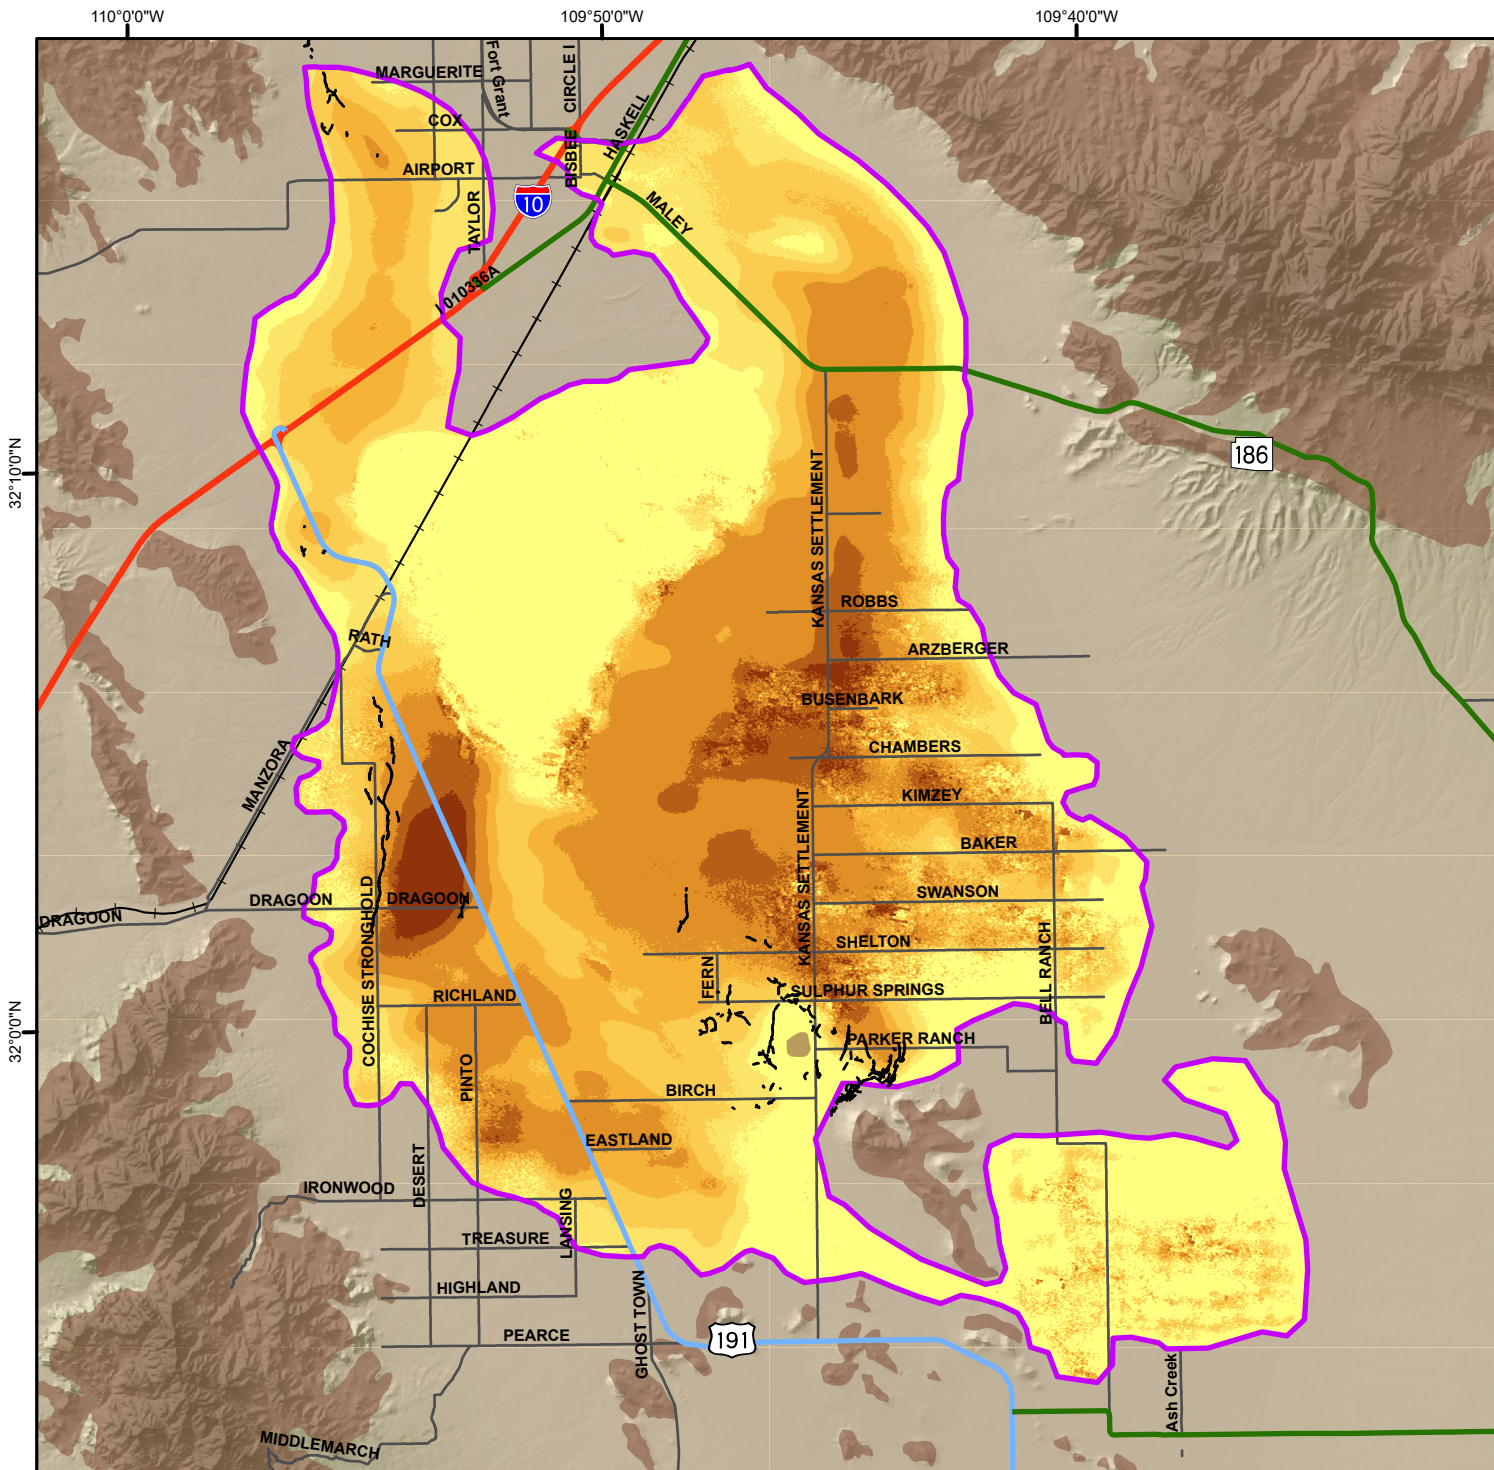
Decorrelation (white areas) are areas where the phase of the received satellite signal changed between satellite passes, causing the data to be unusable. This occurs in areas where the land surface has been disturbed (i.e. bodies of water, snow, agriculture areas, areas of development, etc).

Earth fissures were mapped by the Arizona Geological Survey. For information on earth fissures visit: www.azgs.az.gov/EFC
